# ***Studying the Effects of the Loram HP Shoulder Ballast Cleaner on Brazilian Heavy-Haul Railways***

**Authors:** Aldo Marconi<sup>1</sup>, Fernando César<sup>1</sup>, Dennis Mathison<sup>2</sup>

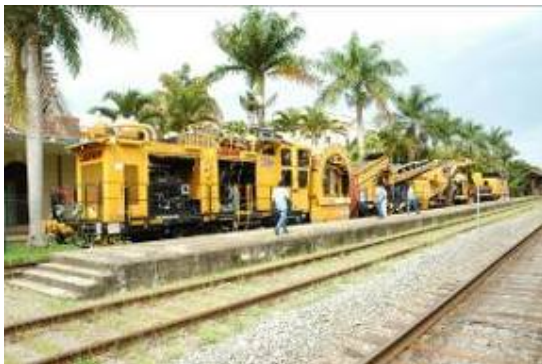
Fig. 2 Loram Shoulder Ballast Cleaner

Using the least track occupancy possible, the SBC has the capacity to clean at 2.0 miles per hour and is completely controlled by a PLC system, reducing maintenance and operational costs. Figure 2 shows a photograph of the machine in the courtyard of the company in Juiz de Fora – MG.

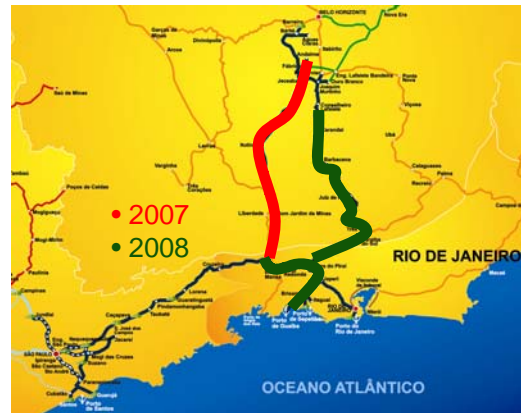
Fig. 3 SBC coverage in 2007 & 2008

Figure 3 illustrates where the machine worked on MRS Lines.

In less than two years of use, the MRS SBC has had an output of approximately 500 miles, operating on a variety of railways and throughout high density traffic. The Steel Line has been a challenge because of the high volume of traffic, and the Center Line because of its highly contaminated ballast and age.

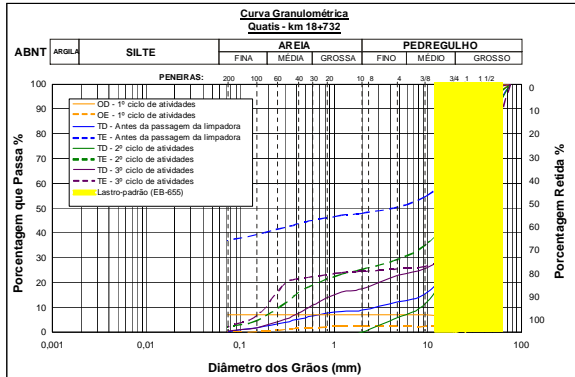
Fig. 5 (a). Compare grain curves from Quatis-RJ

After characterization of the infrastructure, samples were taken from the ballast shoulder at each point before and immediately after cleaning. Also collected were samples of the shoulder ballast to measure the composition of the ballast after a period of rain (see Figure 5).

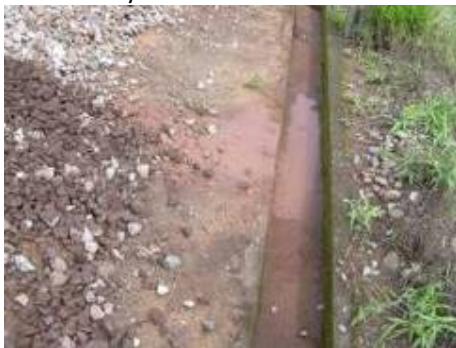
Fig. 7. Fine material carried down by rain water Bom Jardim – MG

The photo shown in Figure 7 shows how fines are carried in ballast. When the shoulder is clear, it means the fouling index is low. The fines can then be carried out by rain water.
